**Subject:** Future of the Westminster Municipal Court Building

# Westminster Municipal Courthouse

**Building Assessment, Programming, and Facility Modernization Study**

**September 19, 2022**

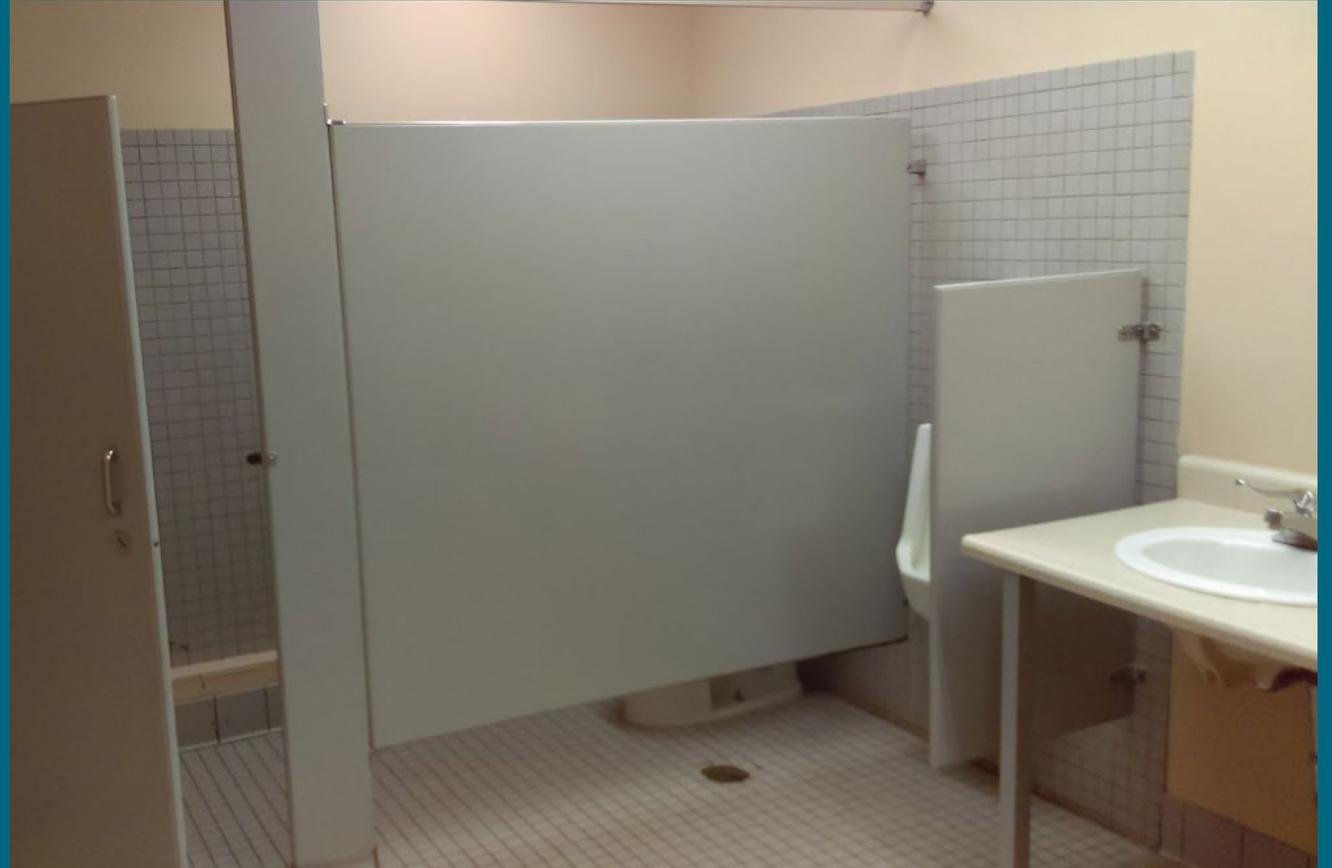
# ACCESSIBILITY ASSESSMENT

- Compliance Issues
  - Common building
  - Circulation routes
  - Restrooms
  - Courtrooms
  - Multi-level access

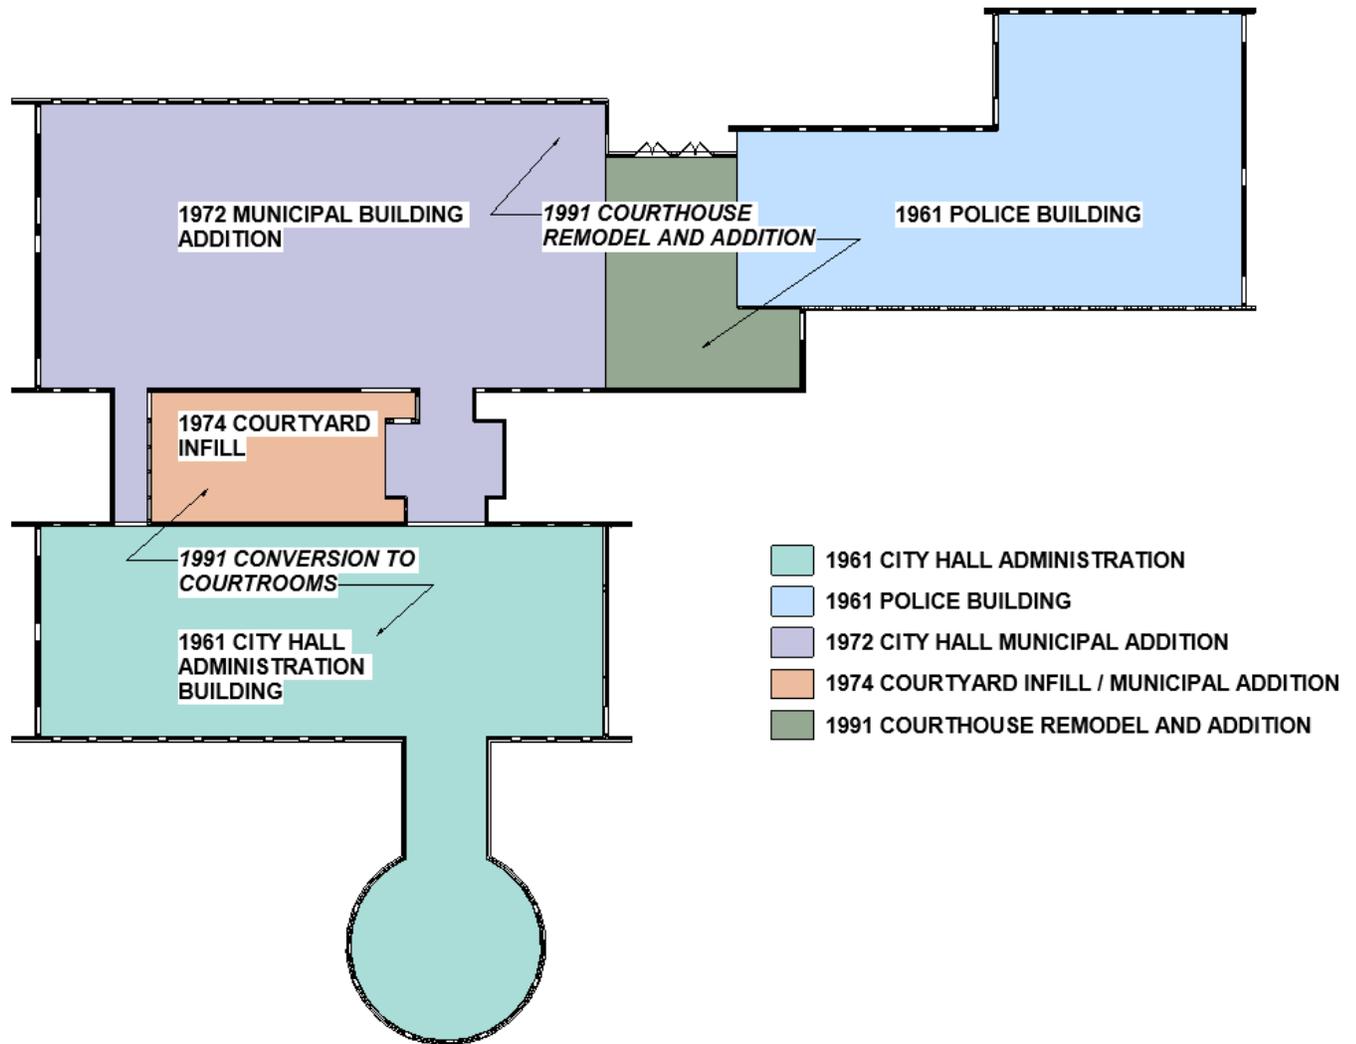
The existing one-story concrete and brick building was converted to its current function as a courthouse during the early 1990s. Prior to that, it served as Westminster City Hall and was composed of two separate buildings, Administration and Police. Several additions have occurred over the years: the first major addition occurred around 1972 when the Municipal Building was infilled to the north of the Administration Building and the west of the Police Station. The Municipal area was connected to the Administration area by two hallways and a courtyard was formed between the two volumes. A couple of years later around 1974, the courtyard was infilled to add additional City staff offices. The major conversion to a courthouse occurred around 1991 when both the original Administration Building and the infilled courtyard areas were converted to courtrooms and holding cells were added to the basement.

*Two original 1961 Buildings, in green – City Hall, and blue – Police. Subsequent additions and infills include the 1972 extension of City Hall with the Municipal Addition, the 1974 Courtyard Infill Municipal Addition, and the 1991 Courthouse Renovation and Addition at the Main Entry*

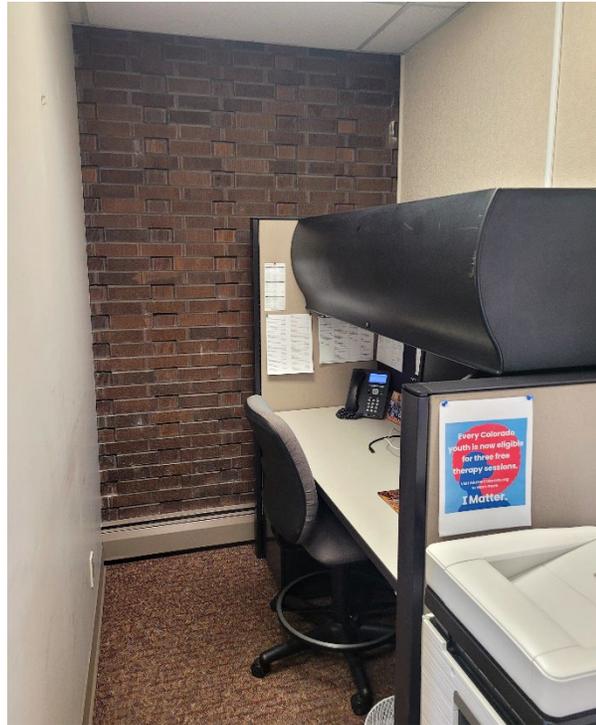
- The Victim Advocates area is undersized, and offices are not ADA-compliant due to the lack of turning radius outside the desk area. Some offices have no access to daylight or views. Private and sensitive conversations with victims can be overheard since there is no separation between offices and the Waiting Room.

*Undersized Victim Advocates office*

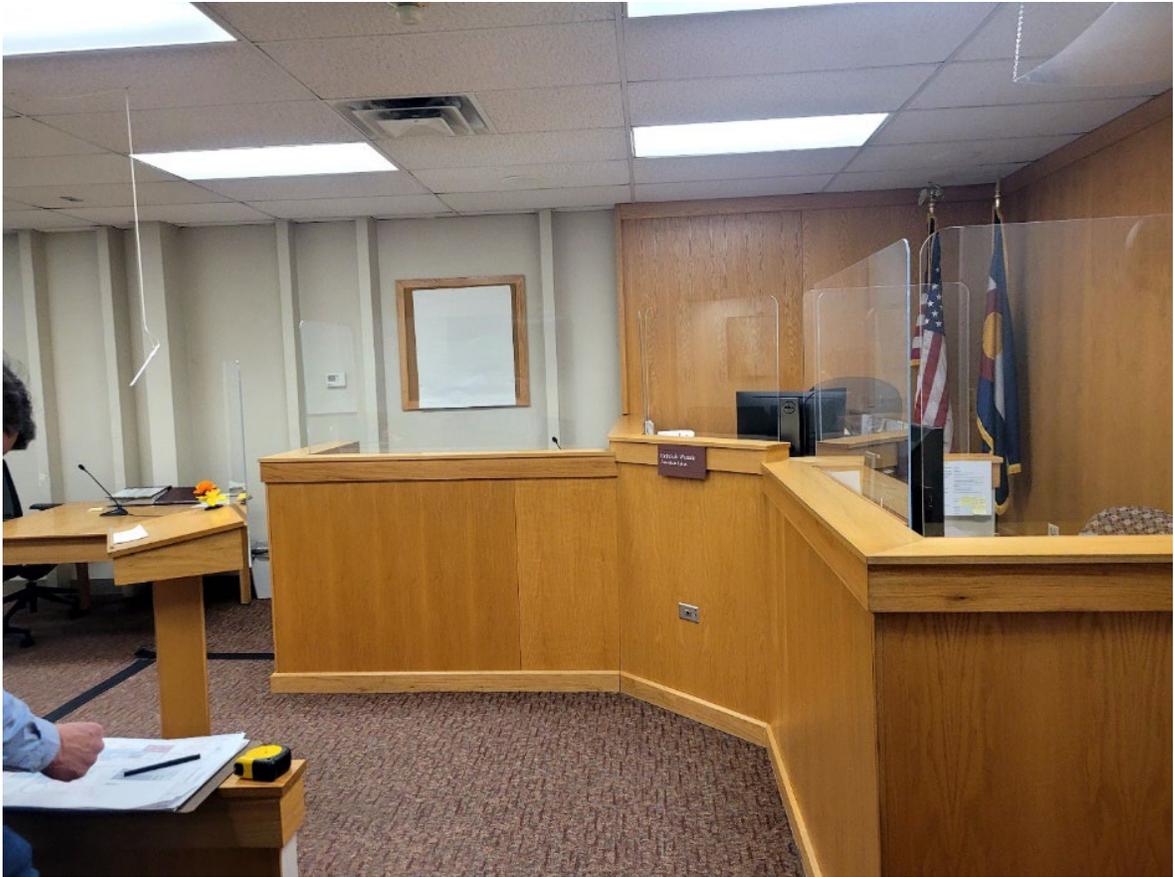
*Courtroom A*

- Courtroom A was infilled from the previous exterior courtyard in the City Hall building.
  - The courtroom is too small and the corner configuration of the bench creates line-of-site issues for the judge during proceedings.
  - The precast tee structure of the walls is constraining for additional infrastructure in the courtrooms.
  - There is no accessible judge's bench or witness stand.
- Courtroom B was carved out of the original 1961 City Hall building and generally functions well with its larger size, though the courtroom lacks an accessible judge's bench and witness stands.
  - Courtroom B does not allow the counsel or defendants to have a clear line of sight to the witness stand or the jury box.
  - Integrated A/V equipment and better viewing angles to the digital screens are needed as many caseloads remain virtual.

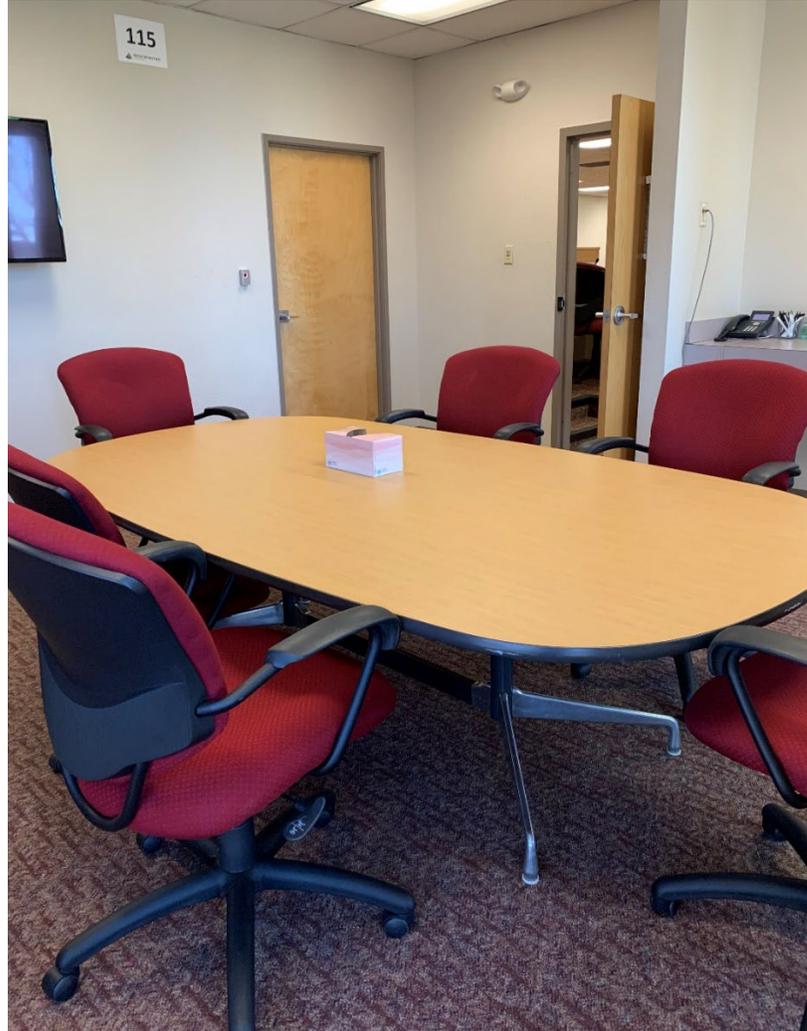
*Courtroom B Jury Deliberation Room with Courtroom B visible through the open door*

- The Jury Deliberation Room west of the courtroom is not soundproofed and conversations from the courtroom (or vice versa) can be heard during jury deliberations.
- Juror deliberation rooms should have a private restroom to reduce the possibility of unwanted interactions should jurors need to use publicly-accessed restrooms. Currently, jurors must leave the deliberation room and go through the courtroom to use the single restroom available to the public.

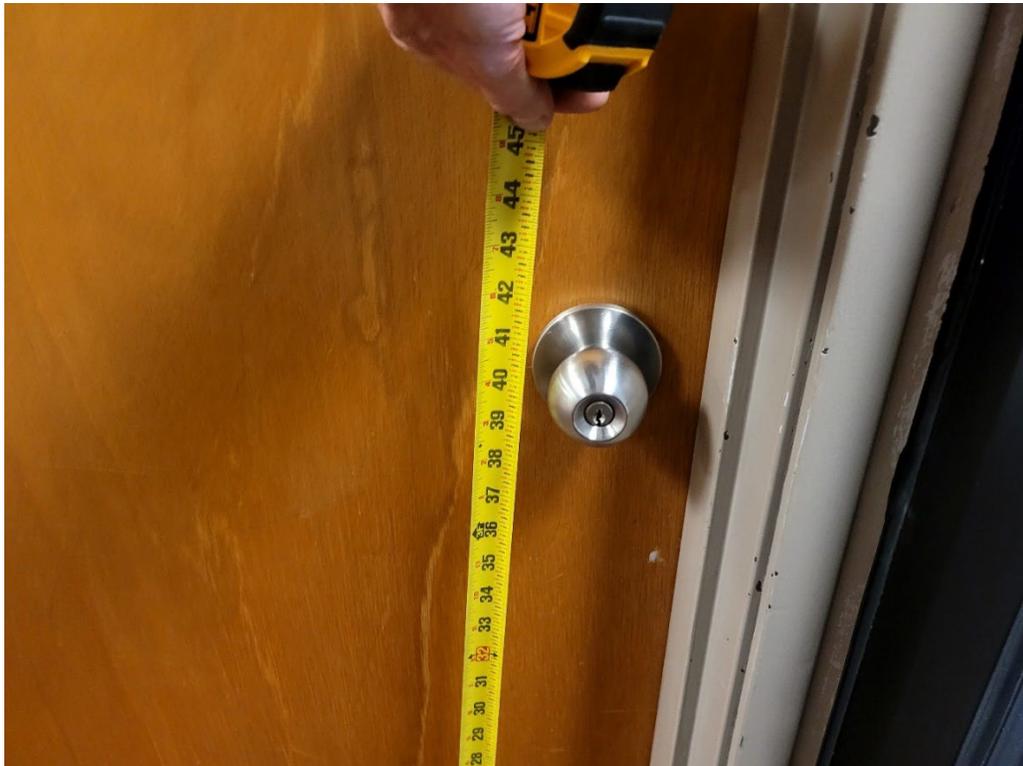
In addition, handsets were installed at varying, non-standard heights throughout the building, though still within the code-required height range. See the image below where hardware is mounted at 40” instead of the typical 36”, hardware varied between 36” and 42” heights throughout the building.

*Example of typical non-ADA compliant door hardware and hardware height*

Solution: Replace hardware with lever-type handsets (hardware at inconsistent, yet code-compliant heights may remain unless door panels are replaced) which meet the following ANSI A117.1-2017 requirements:

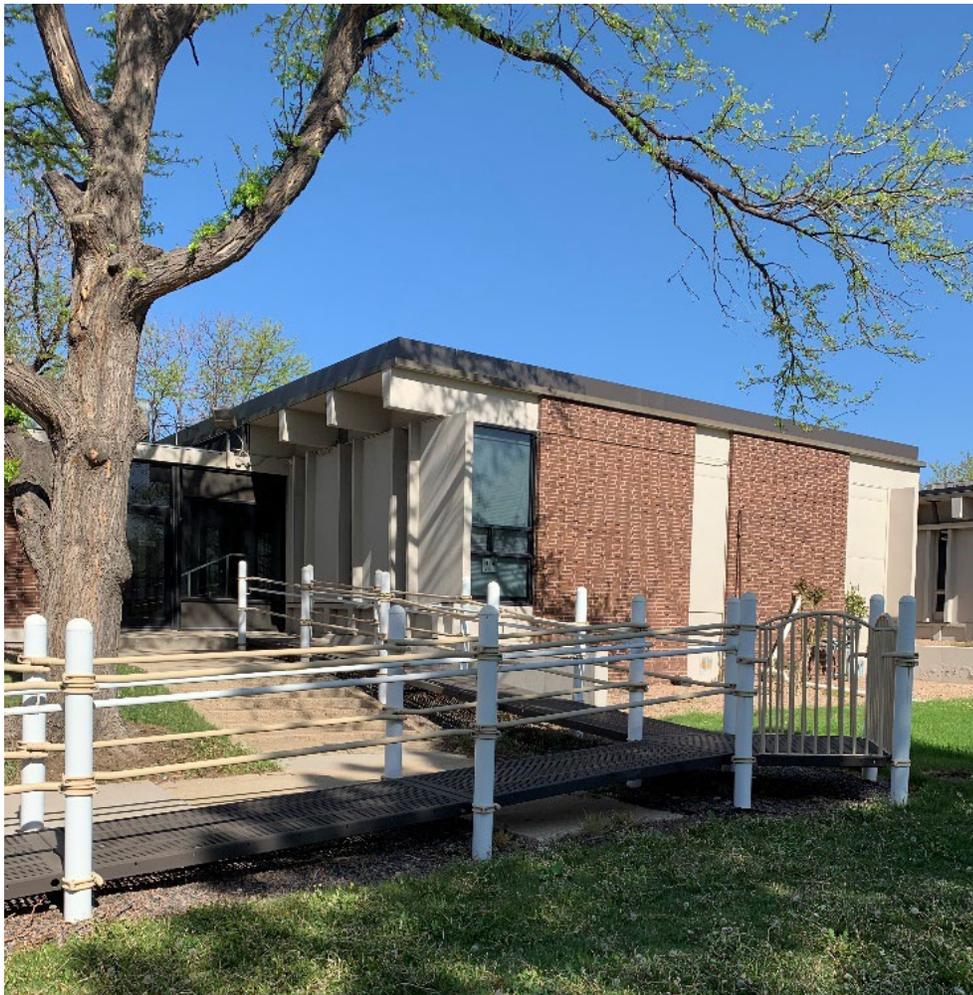
The exterior ramp was the only option for direct access to the Round Room until September 2022 when an internal ADA lift installation was completed. The lift was added to provide an interior accessible route, per IBC 1104, and took place well after Anderson Hallas began their Municipal Court assessment.

*ADA ramp access to the Round Room*

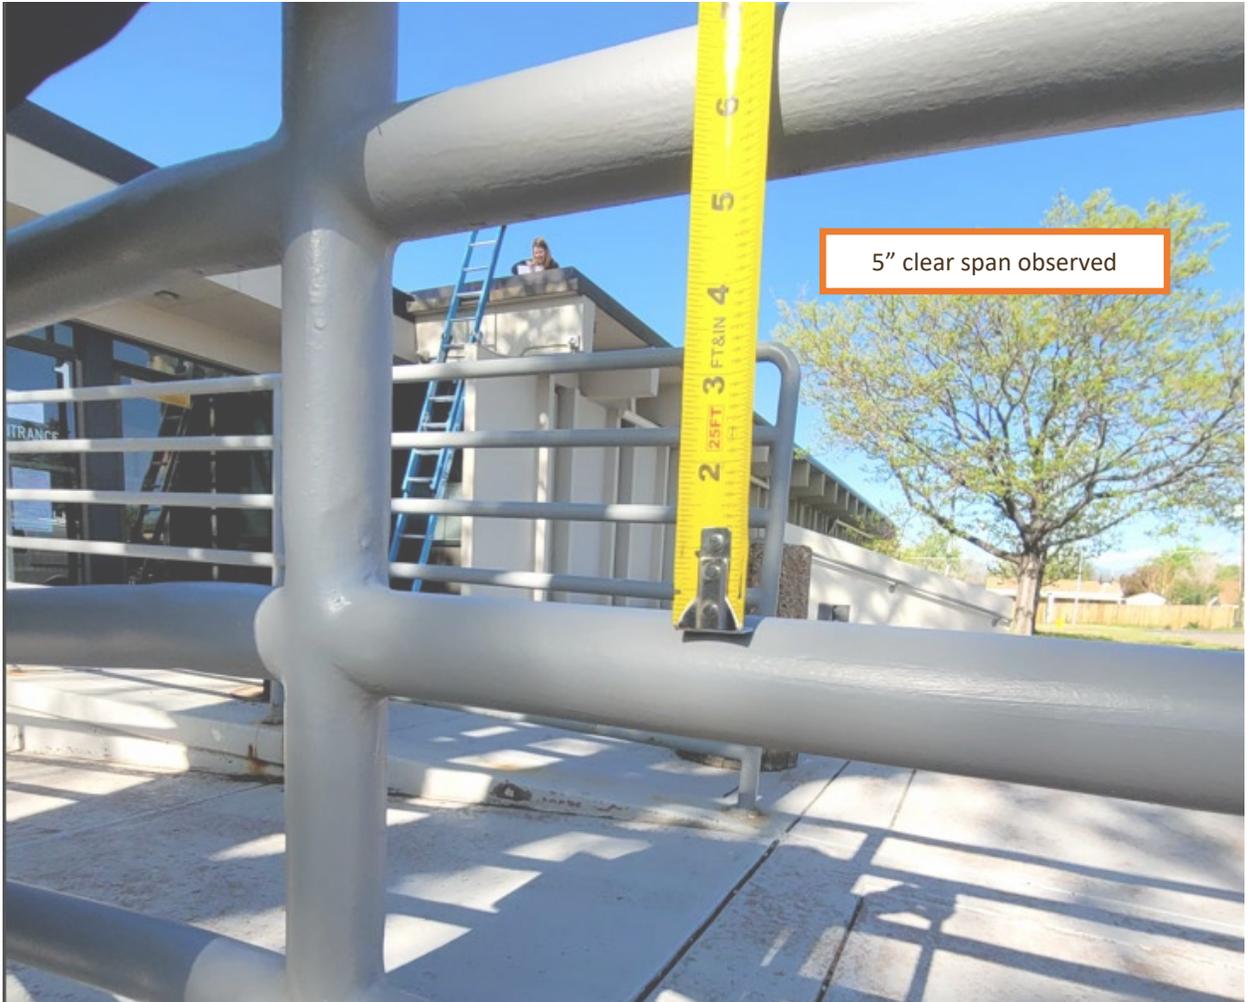
The accessible ramp located adjacent to the main entrance on the north side of the building was observed to have a guardrail with non-compliant spacing between horizontal protective members. A 5" clear span was observed, versus the 4" opening permitted by code.

*Guardrail along the ADA ramp to the main entrance*

The guardrail pictured above does not meet the code and would need to be replaced with a new guardrail that meets the following IBC requirement:

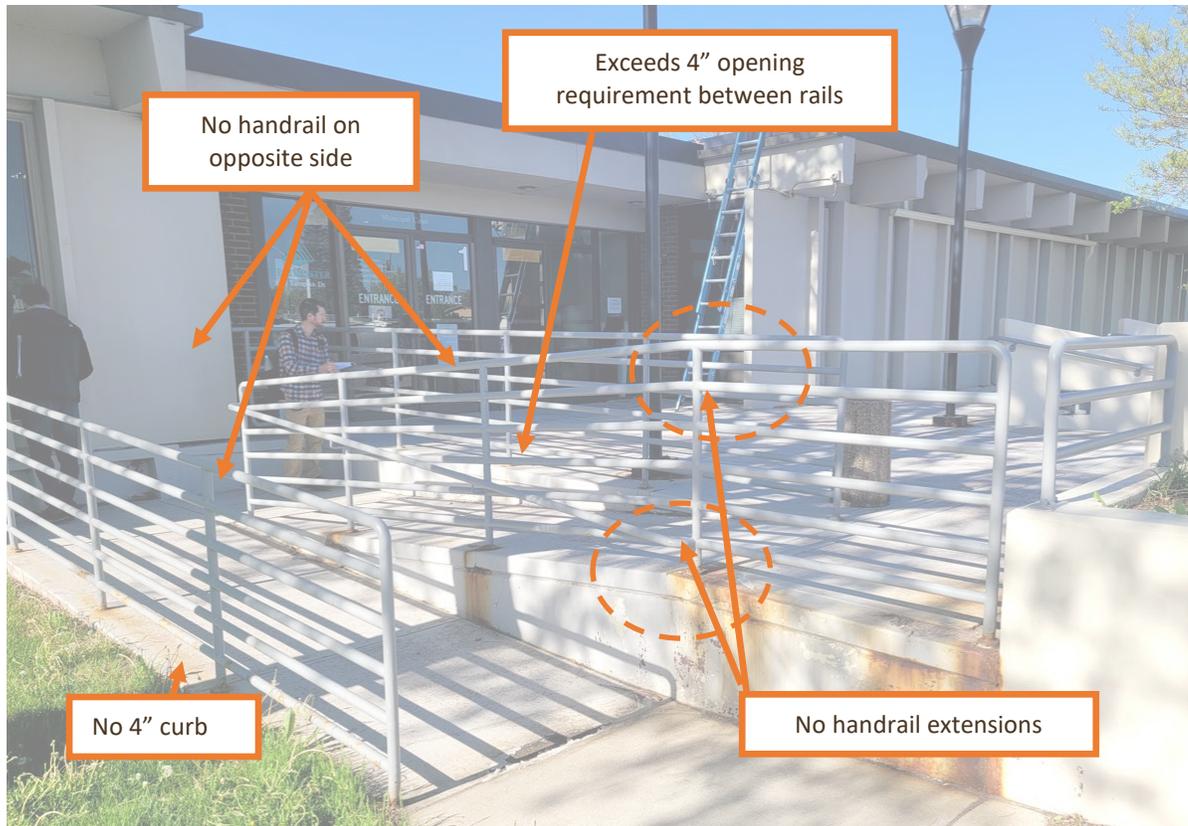
Furthermore, the same guardrail has a non-compliant handrail. The handrail is only on one side of the ramp run and the handrail that is provided does not have extensions at the bottom of the run.

*Handrails along the ADA ramp to the main entrance*

Solution: The handrails pictured above would need to be replaced along with the associated new guardrail to meet the following ANSI A117.1-2017 requirements:

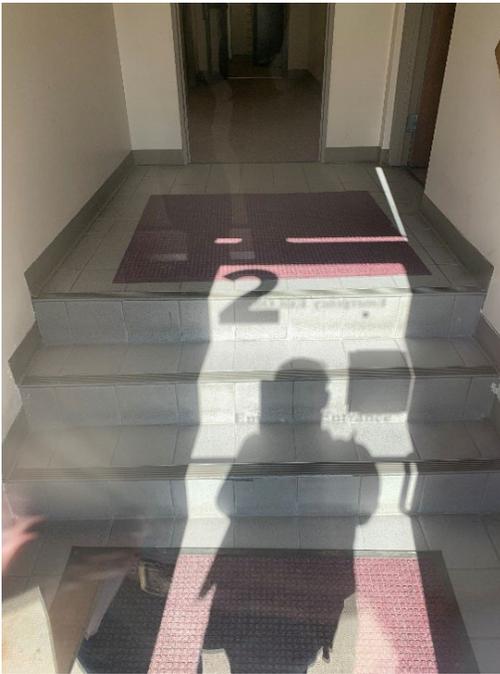
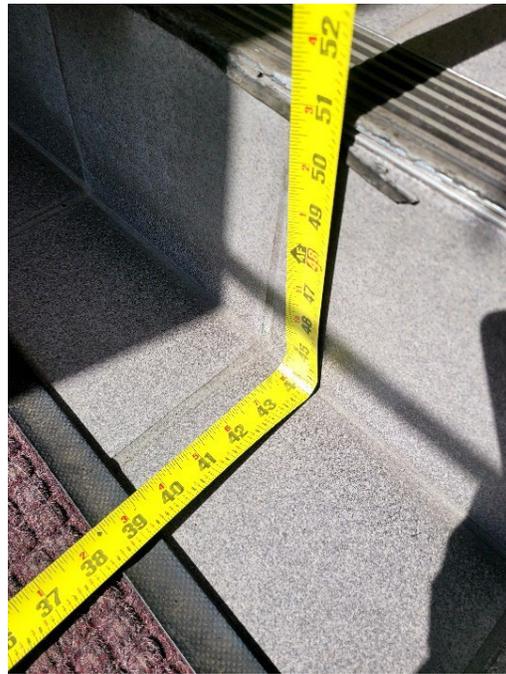
*Non-compliant stair treads*

Stairs should have a minimum tread depth of 11" and risers with a maximum height of 7". The stairs observed at the building department entries and the stairways to the basement are non-compliant, with 10" tread depths (too short) and 8" high risers (too high).

Solution: Reconfigure the building layout to accommodate deeper stair treads. The short stair treads are atypical for users and may cause a tripping hazard; the extra riser height can be difficult for those with mobility issues.

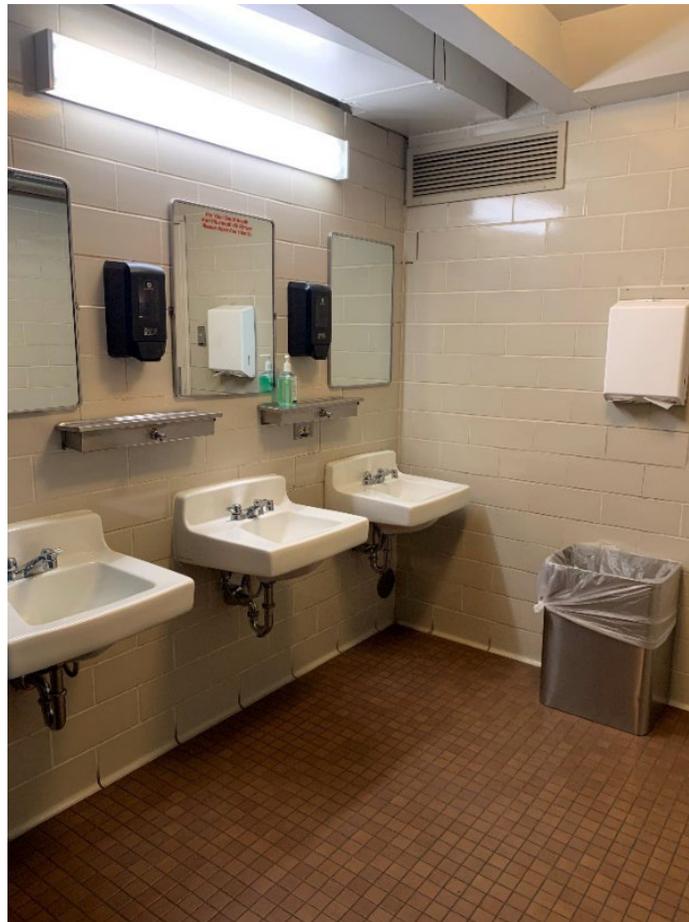
Mirrors, hand dryers, soap dispensers, and other toilet accessories must all be mounted within an accessible reach range.

*Basement restrooms*

Solution: Move the lavatories, mirrors, soap dispensers, and shelves. Patch or replace tiles and CMU walls where toilet accessories have been removed.

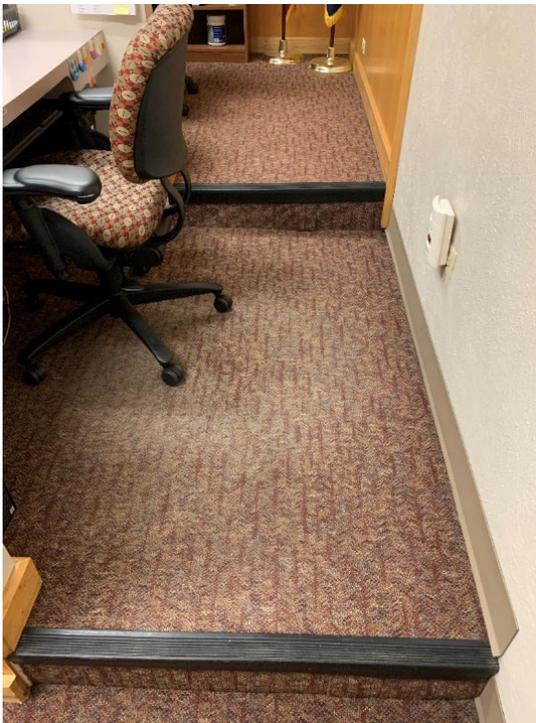
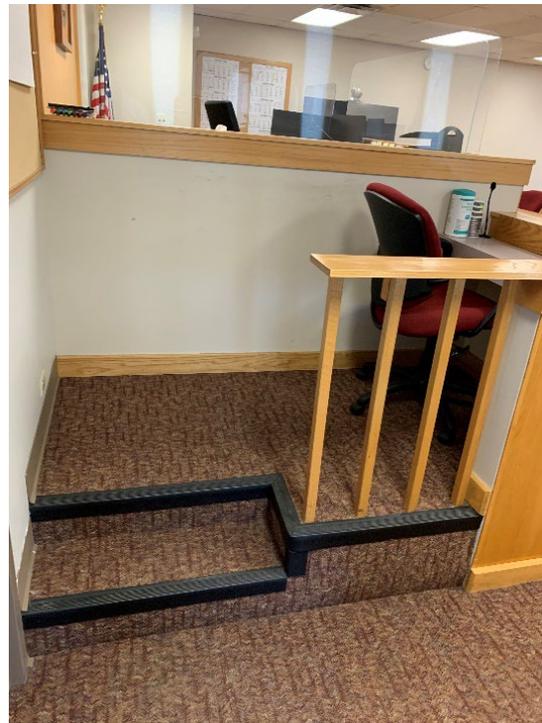
*Non-ADA compliant judge's bench and jury box*

Solution: Reconfigure the space to add ramps or lifts to reach the elevated platforms at the judge's bench and the witness box. This would allow for equal employment opportunities for judges and other staff, as well as access for disabled witnesses to testify.

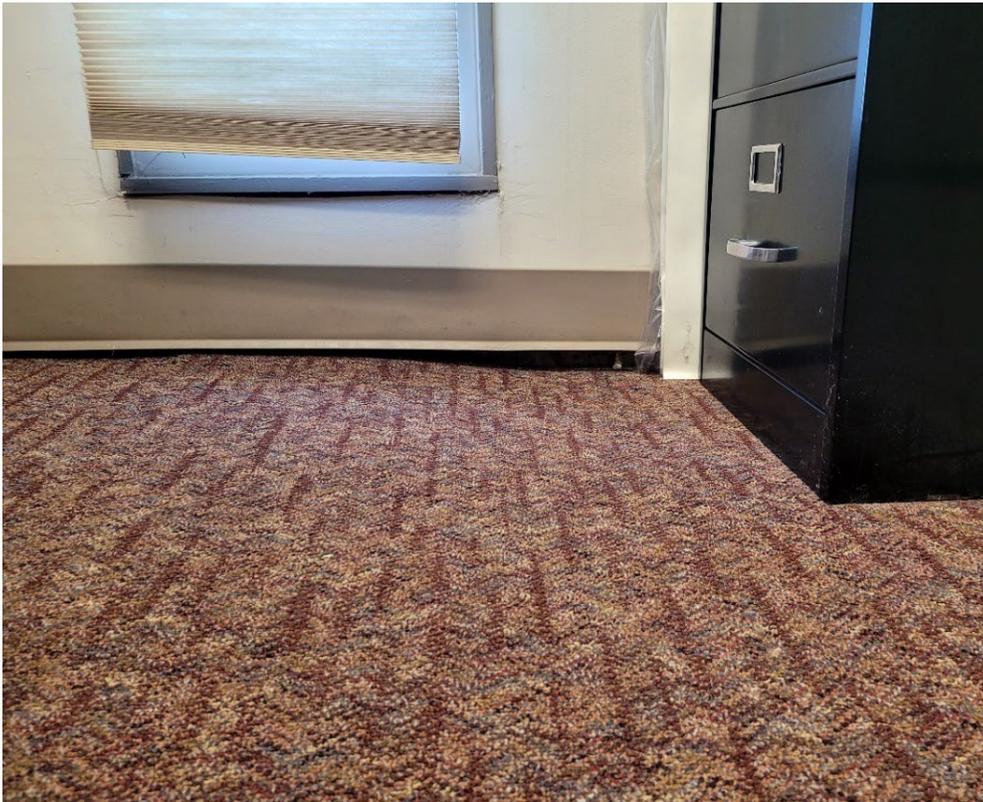
General observations indicate that the foundation system is in good condition with no visually observed evidence of movement due to differential settlement or heaving within the precast bearing walls, or exposed portions of grade beams. The floor system at the first level is in poor to fair condition with moderate cracking and areas of localized settlement of the concrete slab-on-grade adjacent to the perimeter foundation. The settlement creates noticeably sloped floors in many areas of the building, which may cause a tripping hazard. The unlevel surfaces don't meet code requirements, as the degree of sloping would be classified as a ramp. This settlement is likely the result of poor compaction of fill material adjacent to the foundation elements, with some areas exhibiting settlement on the magnitude of 1 to 3-inches. Although the condition is not ideal, the building is stable according to a study of the building completed in 2021.

*Unlevel floor surface around the perimeter of floor slab due to differential settlement*

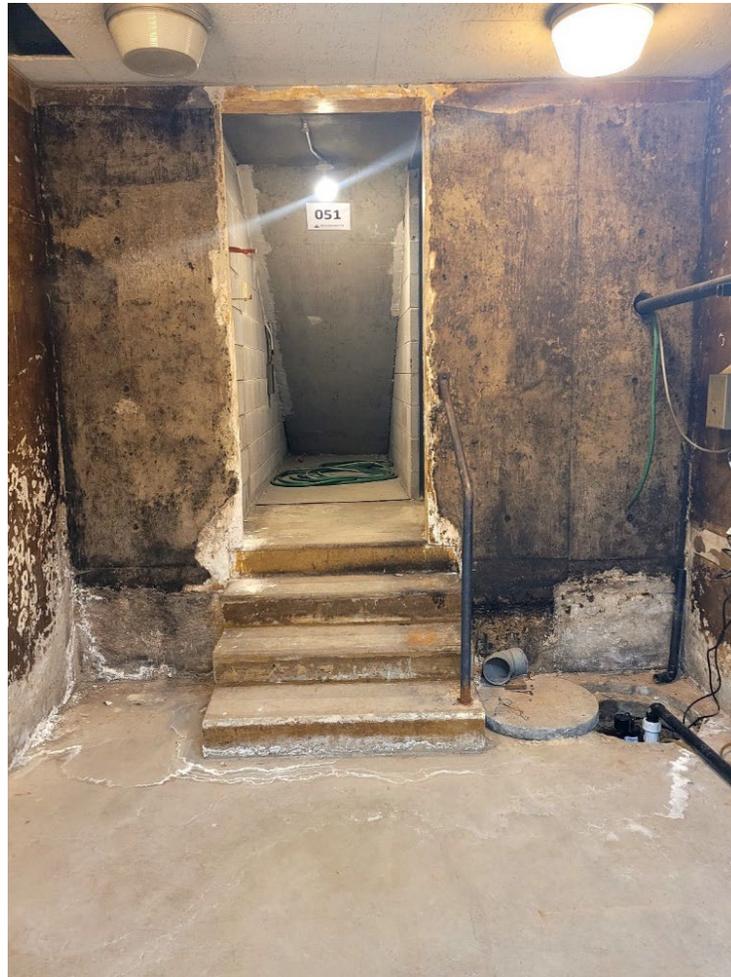
Water intrusion was observed in the former shooting range in the north basement and could further deteriorate foundations. Exterior foundation excavation is recommended to ensure adequate damp proofing and below-grade foundation drainage.

*Evidence of water intrusion in the basement*

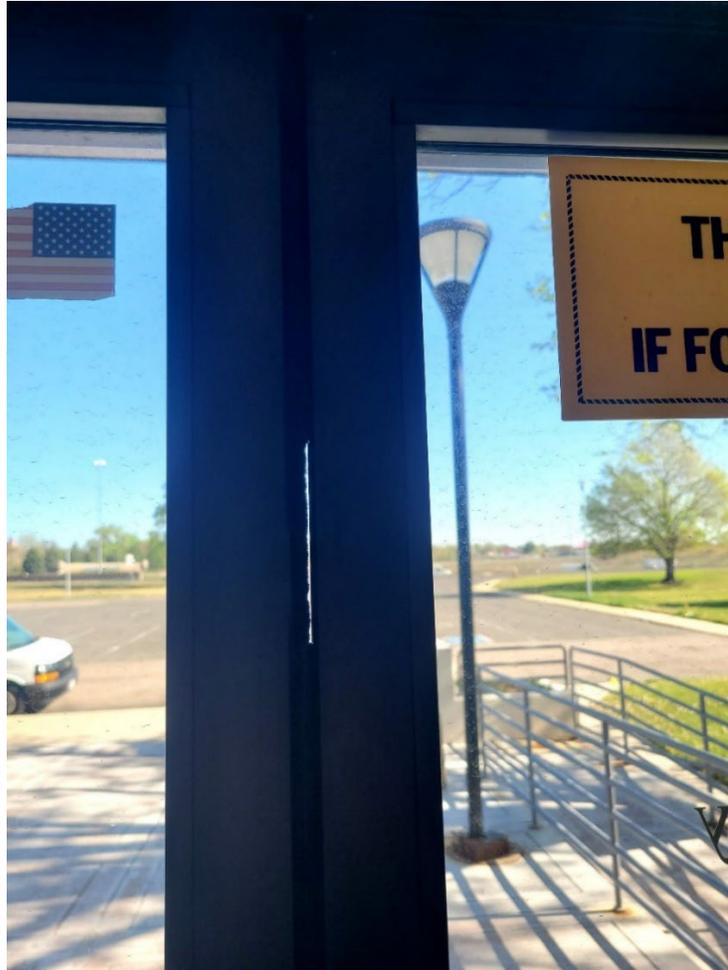
The exterior doors and windows throughout the building leak, which are a major source of air intrusion and should be replaced. Interior doors include solid wood-panel swing doors and hollow-core wood closet doors. Many interior doors lack code-compliant hardware and there is mismatched hardware throughout, with handles installed at varying heights from 36" to 42" (see ADA Assessment for further detail).

*Main entry doors with worn-away / missing seal*

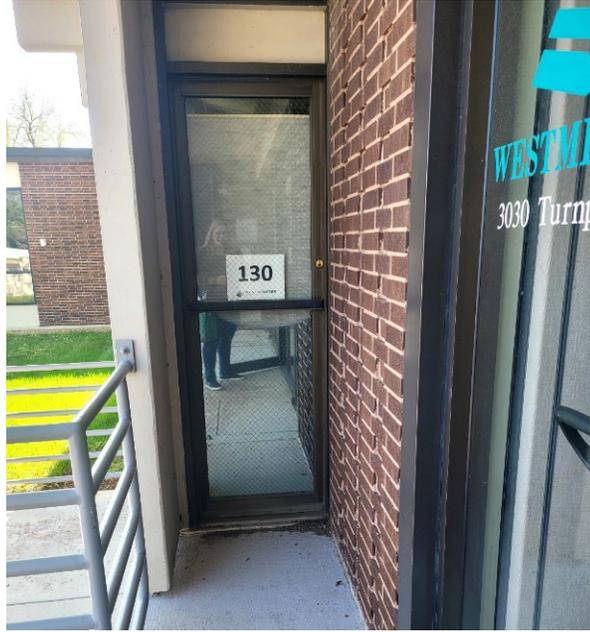
*The door to the left of the main entrance is only 27" wide (non-code compliant) and has been sealed off for use as a door but still may be a vulnerable entry point.*

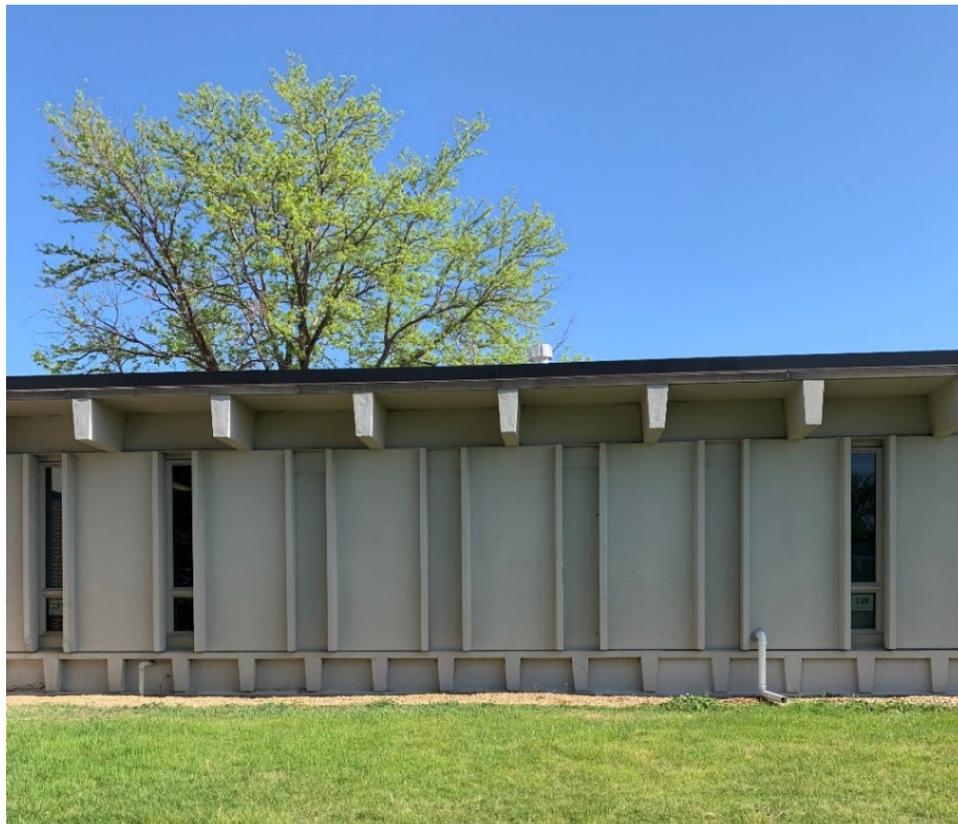
*Some original window openings have been infilled due to conflicts with the interior layout configuration.*

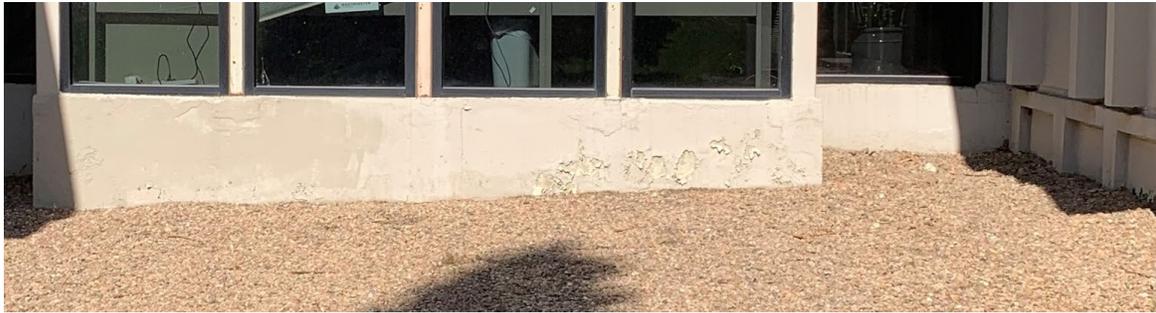
*Peeling paint is observed on the foundation walls.*

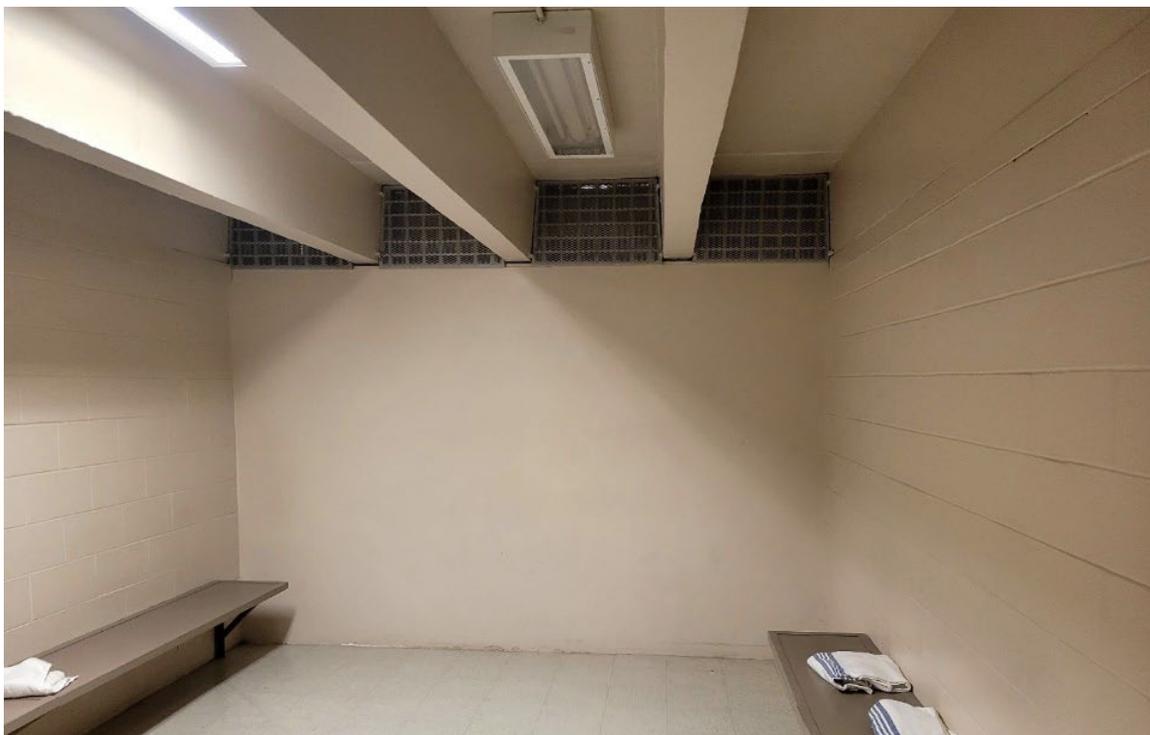
*Gaps between the top of the wall to the double tee floor structure within the holding cells in the basement were observed. Cold air leakage is likely.*

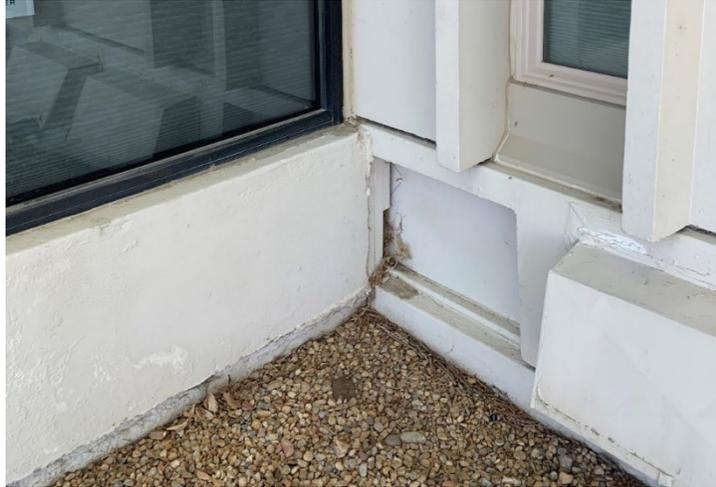
*Unsealed corner joint intersection at windows and foundations.*

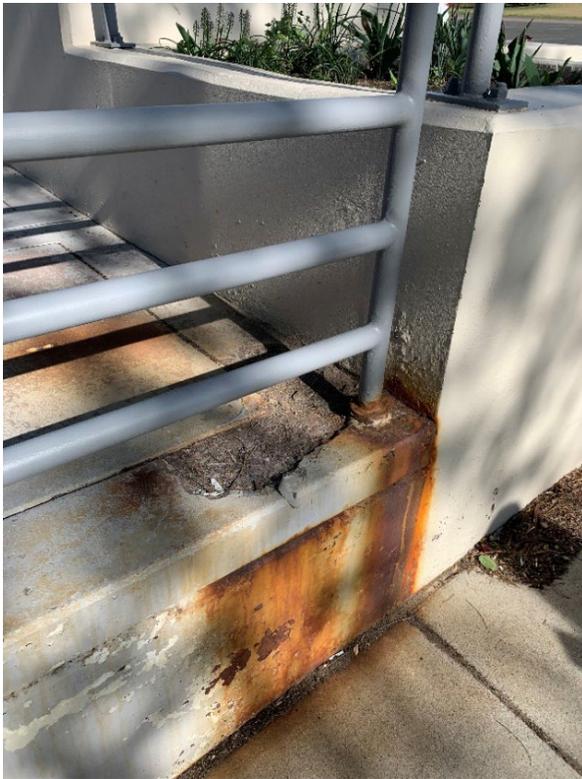
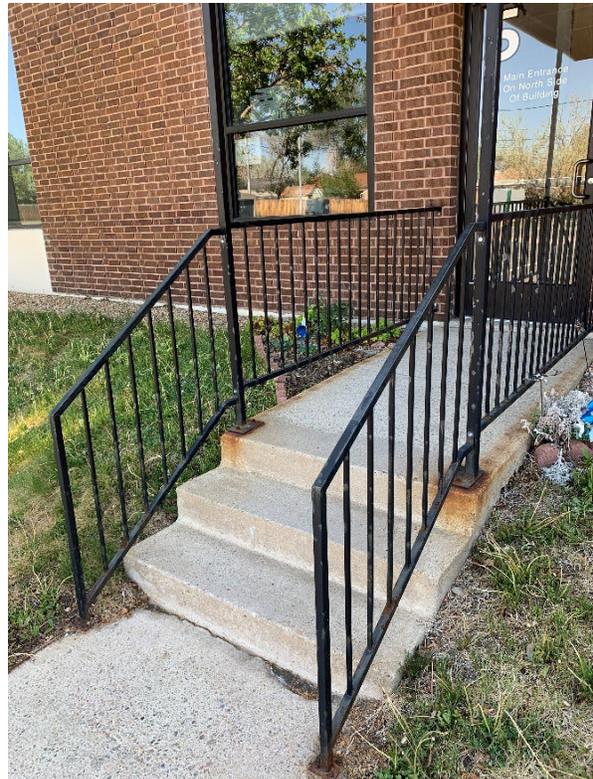
Railings are in poor condition and many had rusted base connections, which could leave them unstable and prone to coming loose when the handrails are used for support. They likely do not meet the IBC section 1607.9.1.1 to bear a concentrated load of 200 pounds in this condition.

*Railings with rusted base connections*

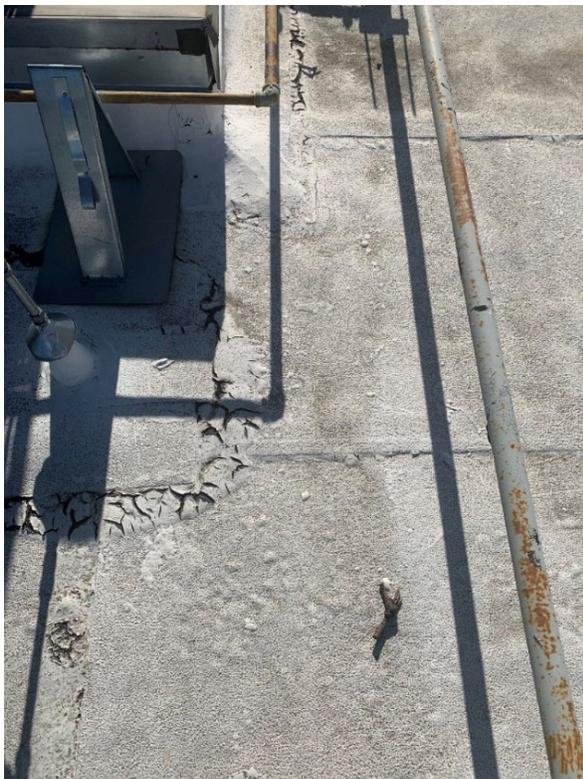
*Blistering and cracking of the roof membrane.*

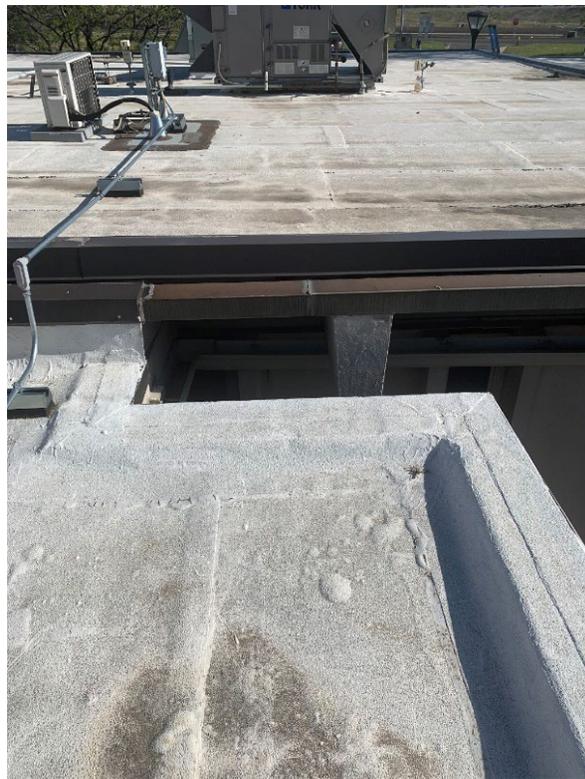
Because of the nature of how the additions evolved and were added over time, the roof has many transitions, steps, and various roof penetrations. The flashing conditions around the infill additions result in retro-fitted and complicated flashing and termination bar conditions, adding to the vulnerability of the existing roof.

*Awkward roof-level transitions and improvised gutters are visible. No parapet cap was provided.*

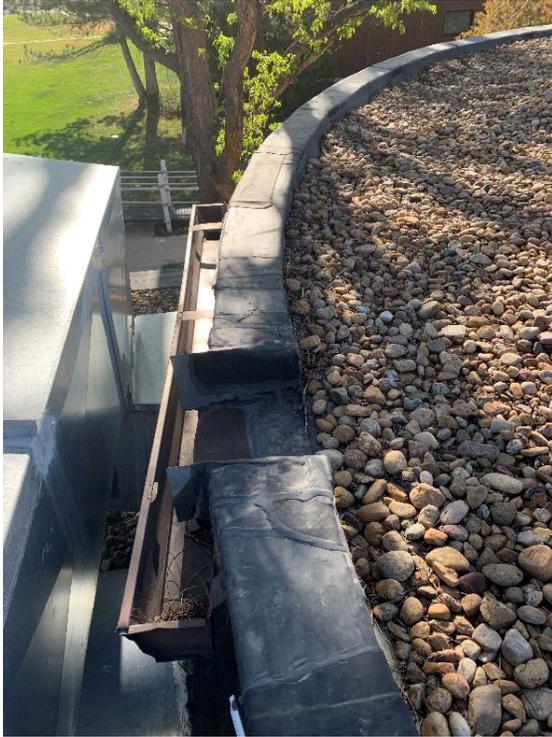
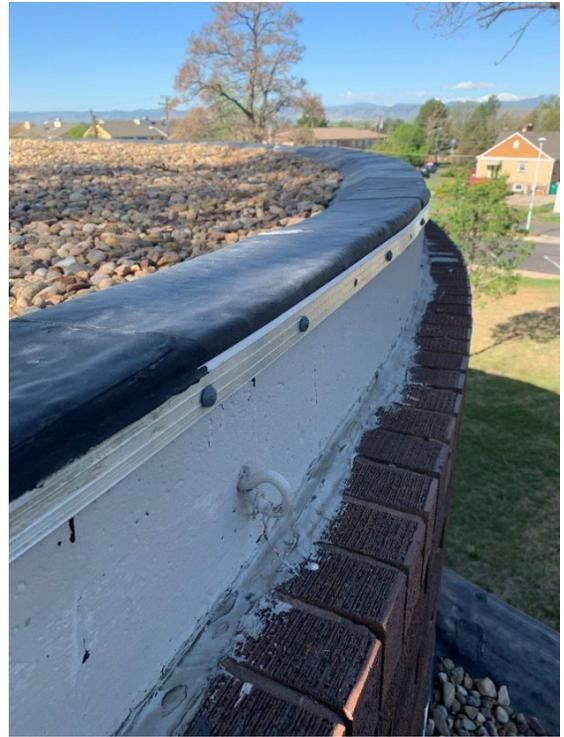
*No metal cap flashing exists on the "Round Room" parapet.*

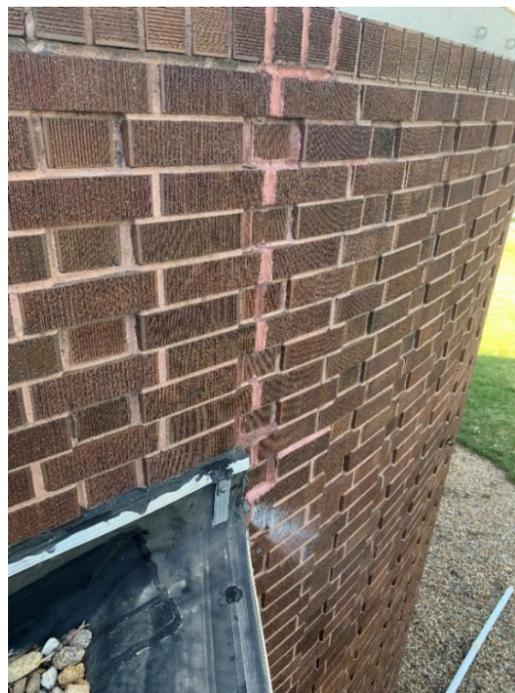
The sealant at the top of the brick is cracking and requires consistent maintenance. It is recommended that metal cap flashing be installed to better preserve the masonry.

*Masonry joint crack likely caused by moisture intrusion at top of the wall.*

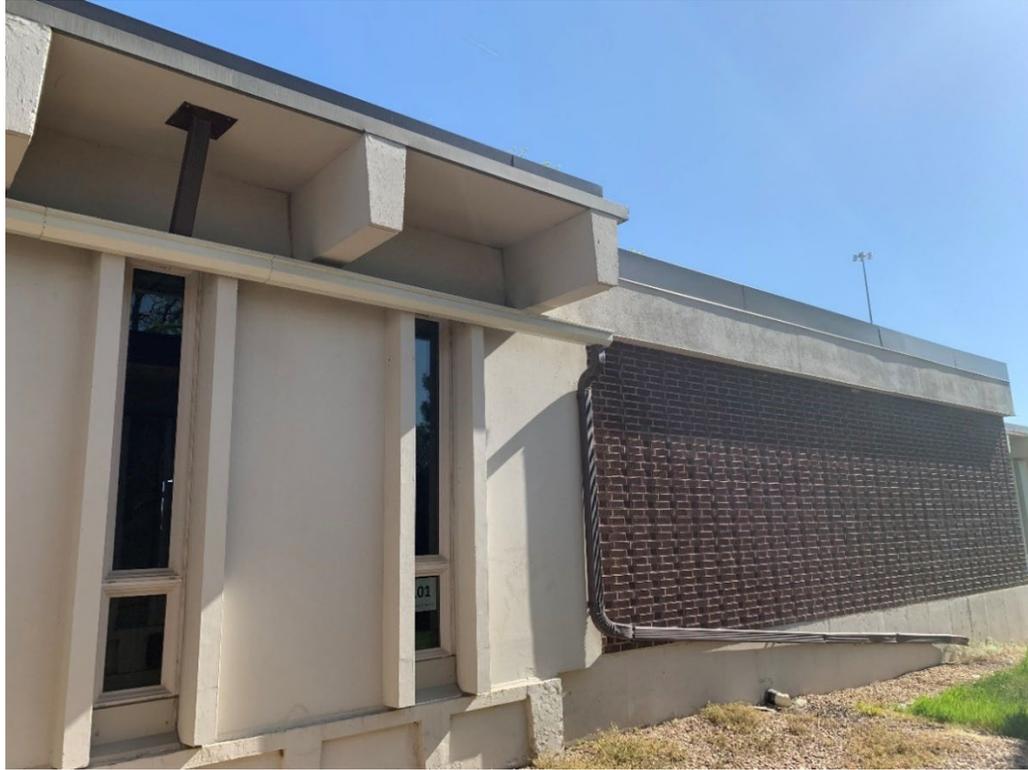
*The gutters appear to be a retrofit below the double-tee of the roof.*

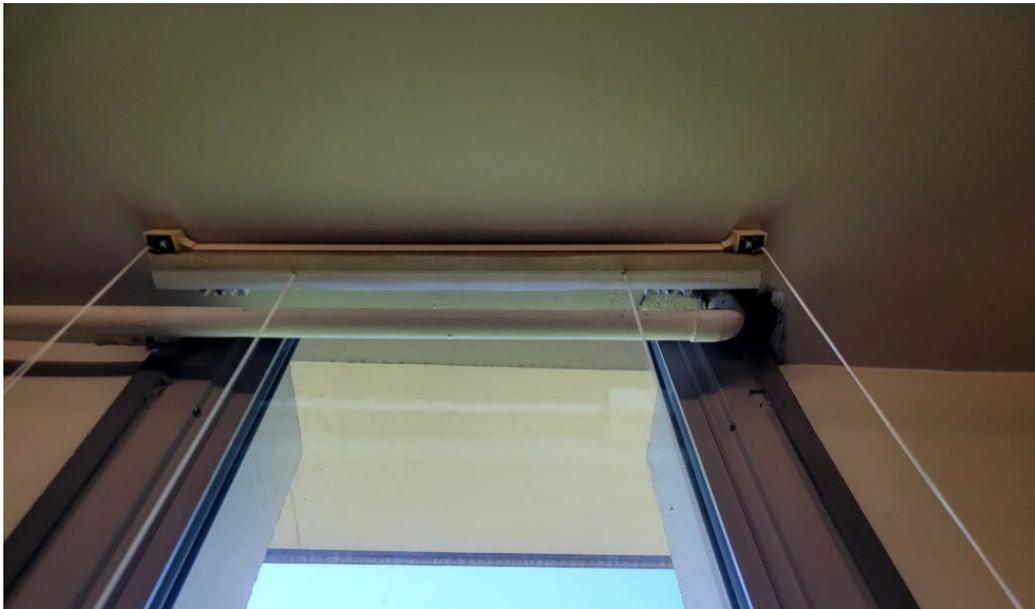
*A roof drain was added in front of an interior window, blocking light and making for an awkward shade installation.*
