**Subject:** Future of the Westminster Municipal Court Building

# Westminster Municipal Courthouse

**Building Assessment, Programming, and Facility Modernization Study**

**September 19, 2022**

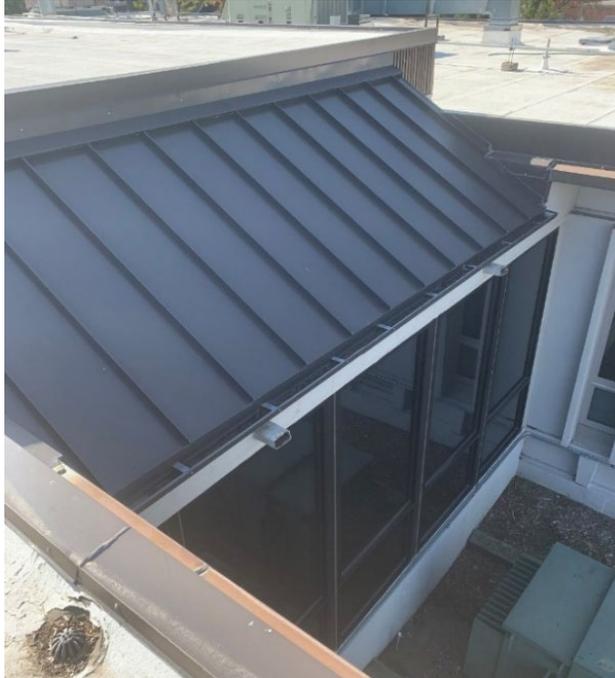
*Gutters that don't connect to a downspout were observed in some locations. These metal roofing additions were required to remedy problematic sections of the roof.*

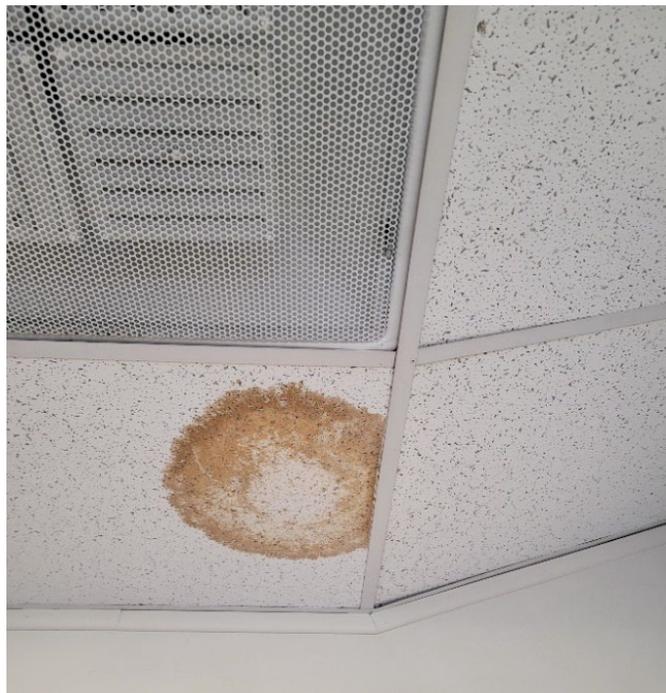
*The ceiling tile is water-damaged from an apparent roof leak.*

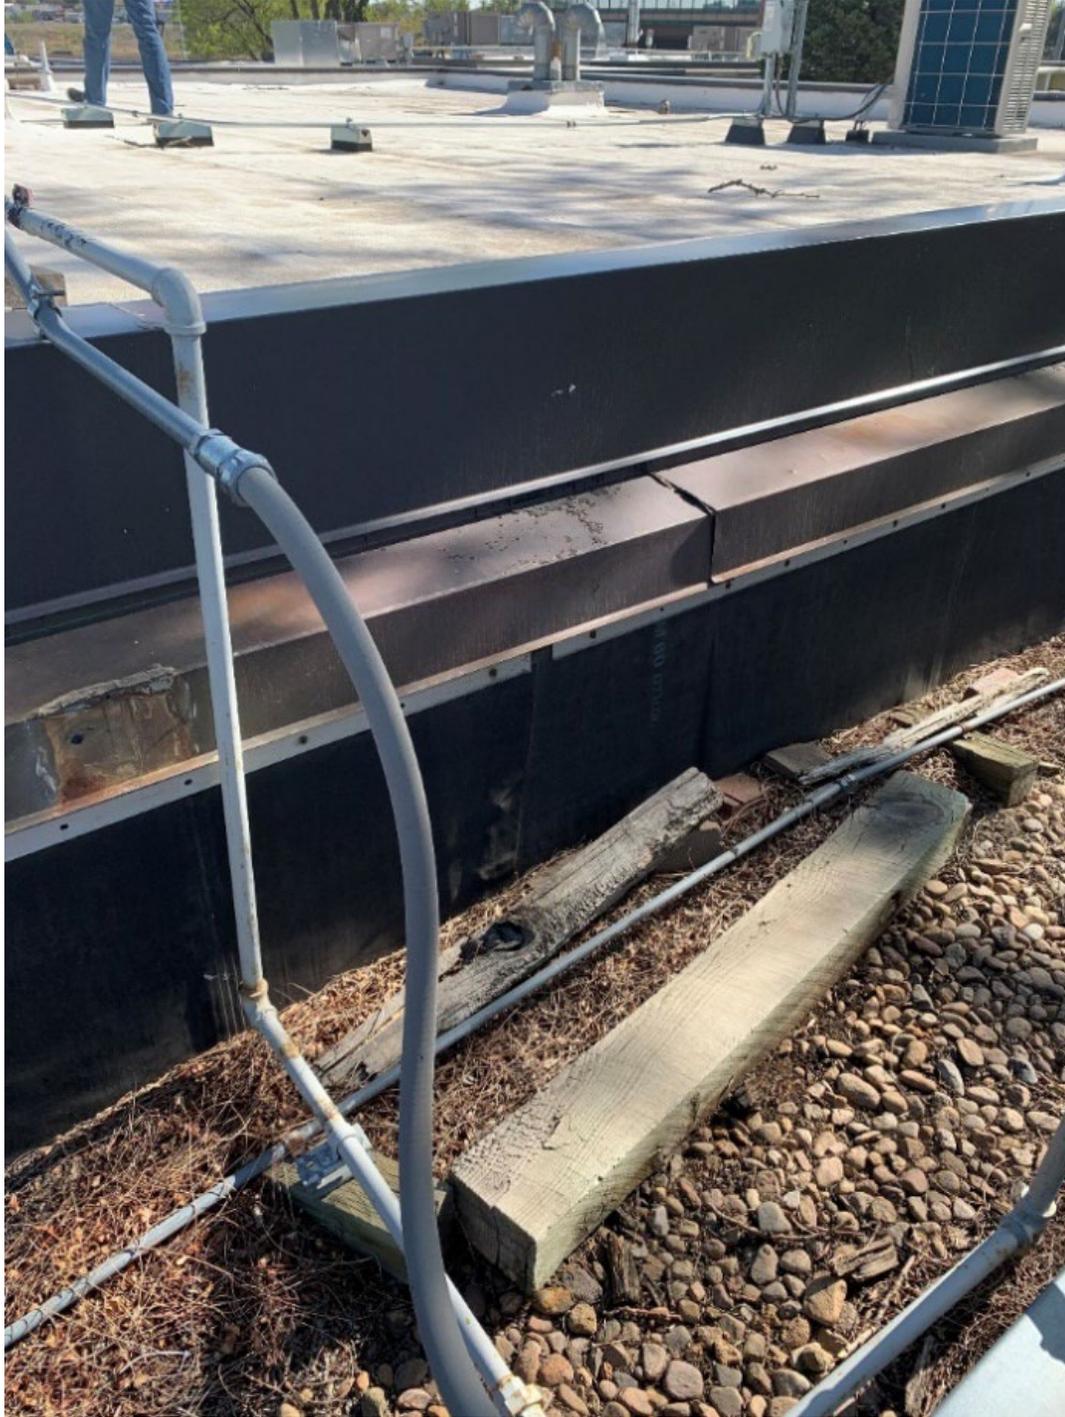
*Rusted sheet metal parapet flashing was observed. Poorly routed and rusting piping exposed on the roof routed to connect between multiple building additions.*

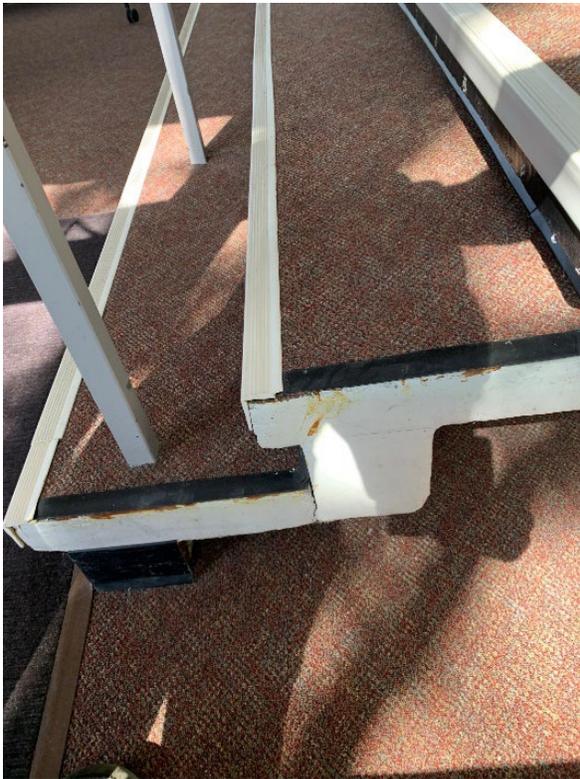
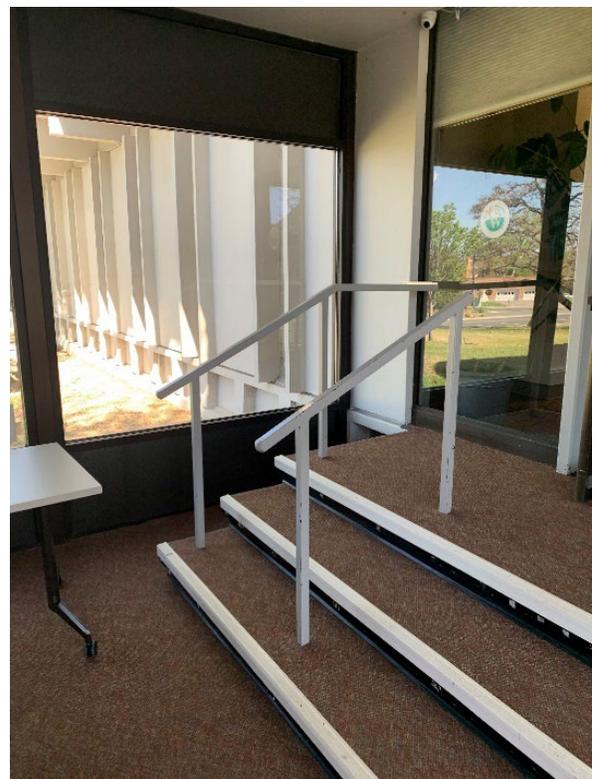
*Precast stair treads are not level and are rusting and in need of replacement.*

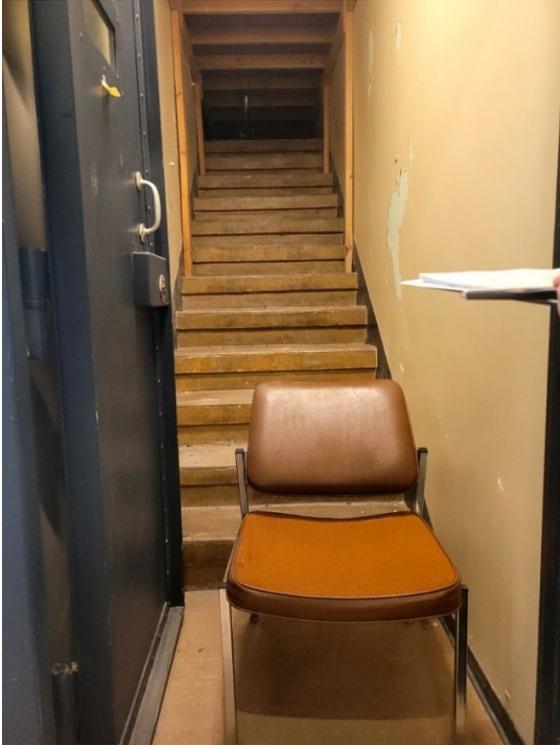
secondary basement stairs have been framed over at the top, but not closed off from below. This creates a potential life-safety issue if a person were to become disoriented and try to exit via this stair in an emergency. Currently, this basement is only used for storage, so occupancy is minimal, but the unsafe conditions remain.

*Framed over stairs in the north basement*

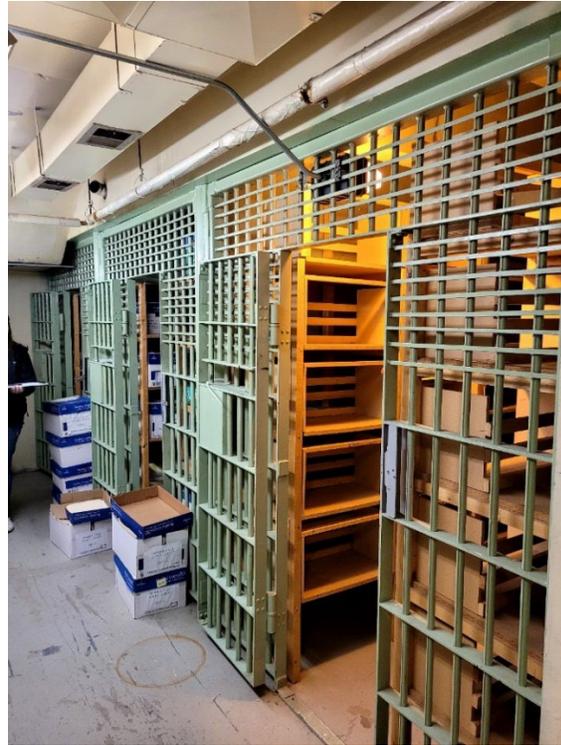
*File storage in the basement jail cells*

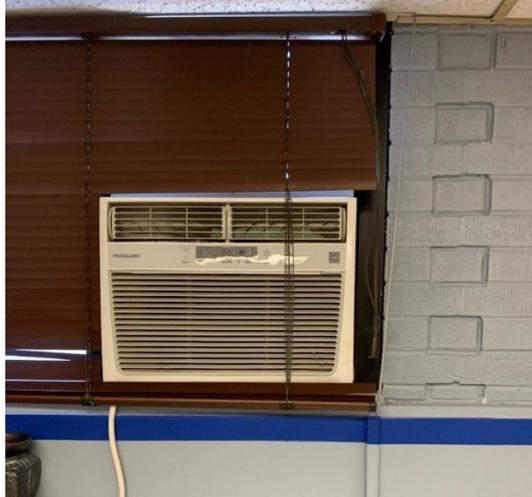
- The Court Marshals' space and existing configuration are adequate but suffer severely from climate control issues. Retrofitted through-window wall A/C units blow directly on desks in the office area, resulting in uncomfortable conditions and irregular temperature control.

*Inefficient window air conditioning unit in basement window of the Court Marshals' office.*
