# Above the Flood: Elevating Your Floodprone House

FEMA 347/ May 2000

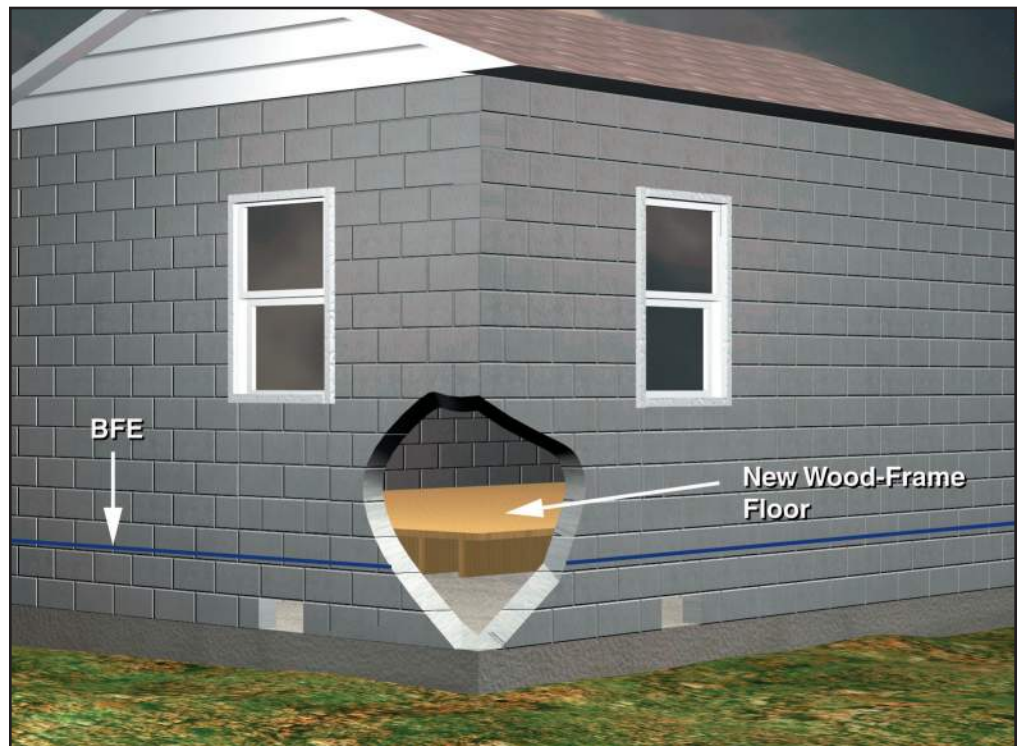
**Figure 13**  
A new wood-frame lowest floor is constructed above the flood level, and the roof, windows, and doors are reinstalled.

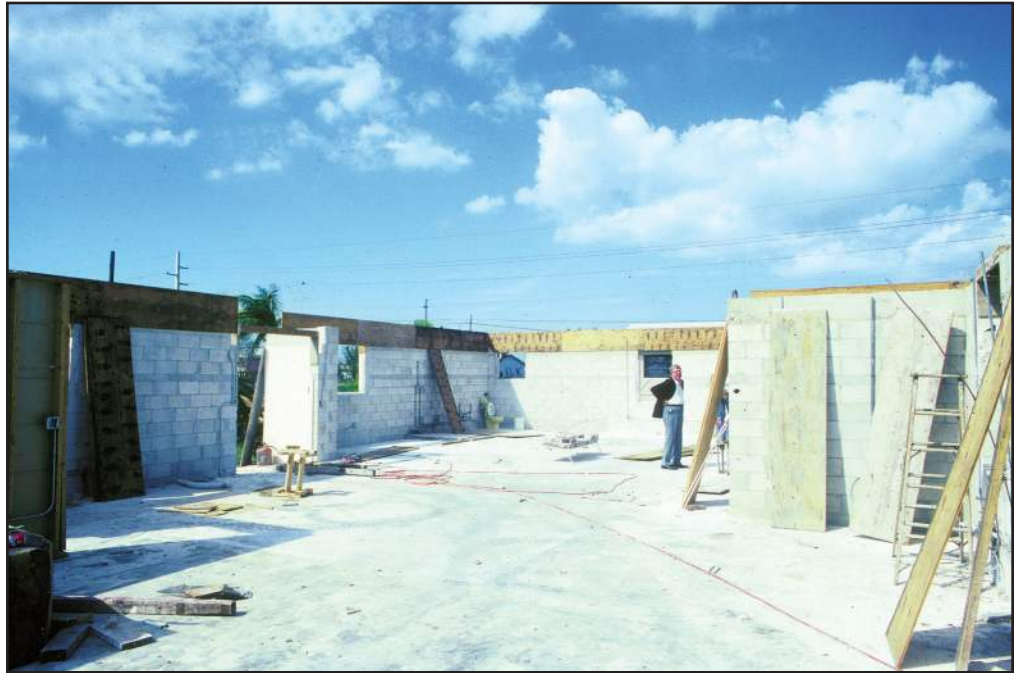
**Figure 40**

After the roof was removed and the storm-damaged interior gutted, the walls of the house were extended upward and a new bond beam added at the top.
